**NEW MEXICO
ENVIRONMENT DEPARTMENT**

Re: Hakes Brothers / Metro Park Village Phase 2; CGP; SIC 1521; NPDES Compliance Evaluation Inspection; NPDES #NMR1001BP; February 13, 2019

NPDES Compliance Inspection Report

NPDES Construction General Permit Inspection Report – State of New Mexico

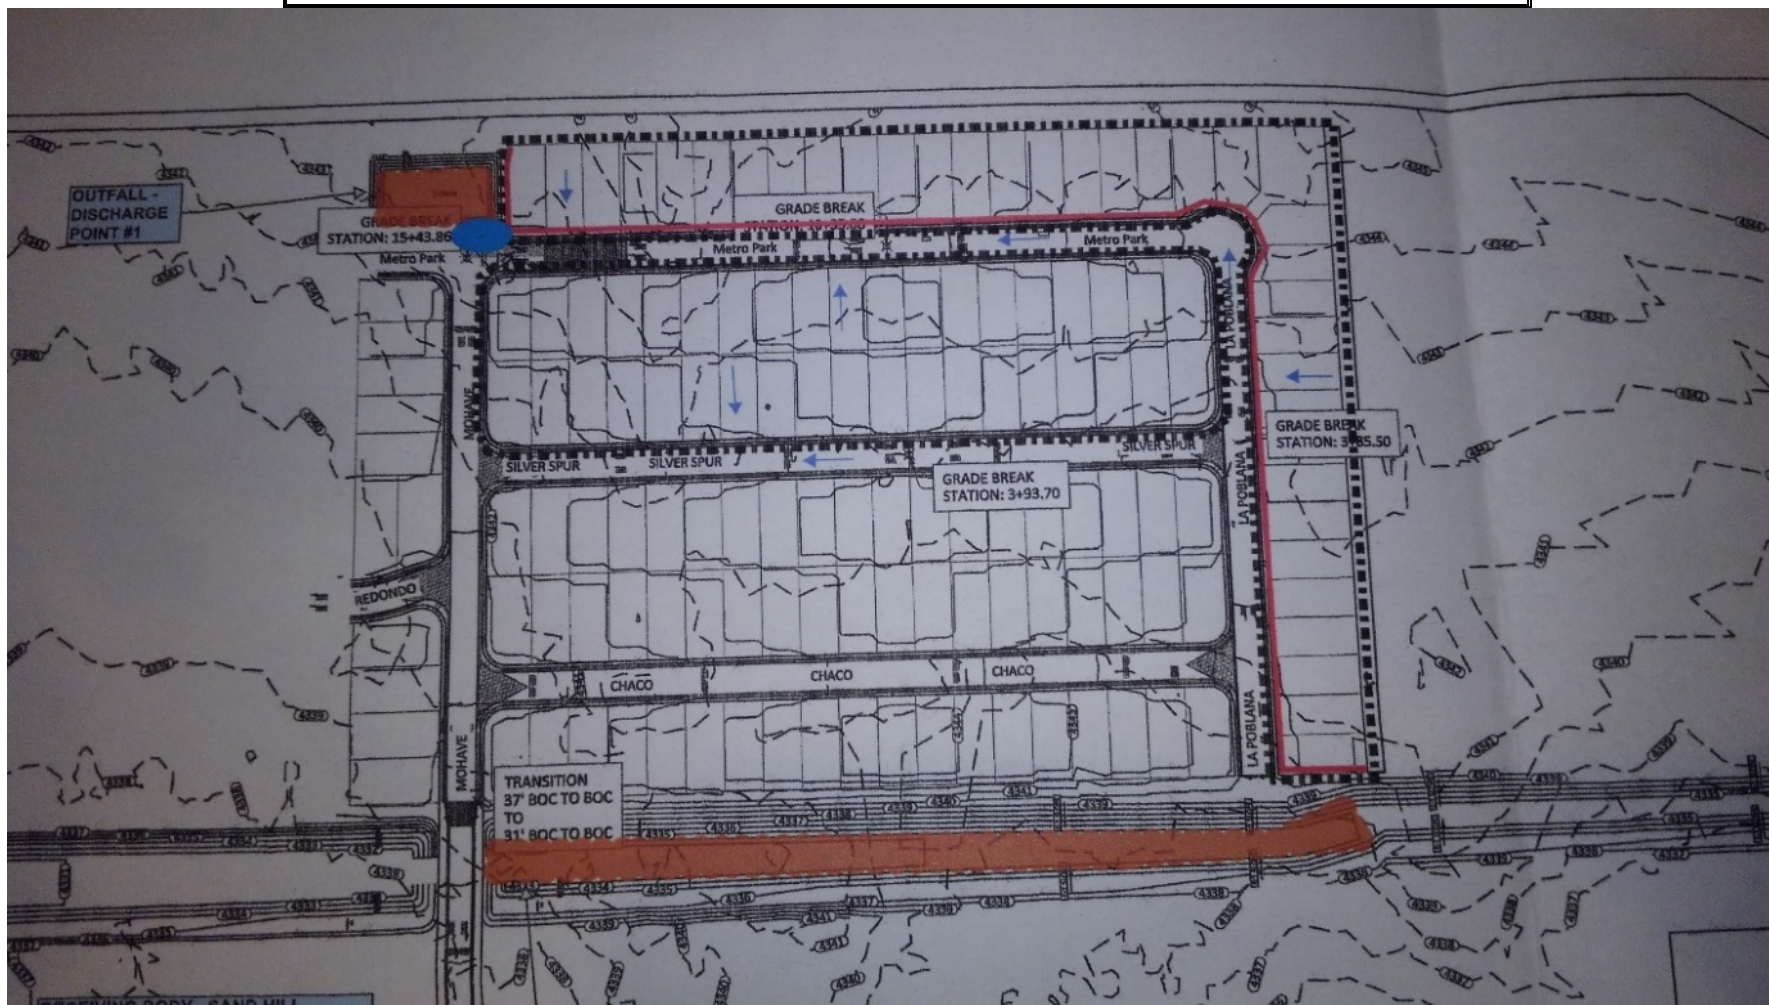
The onsite SWPPP was not certified. The SWPPP cover was dated May 11, 2018. The Stormwater Team needs to be updated. The SWPPP and NOI describes that runoff flows to a new retention pond and will not runoff the site. However, there is currently not an inlet to the outfall#1 pond, water runs to the south instead. The SWPPP also describes that historically the area flows to Sand Hill Arroyo. RUSLE Calcs do not show that erosion is not increased during construction and there are no runoff calculations in the SWPPP. The historic document was missing in the onsite plan appendix. The plan describes a combined staging area with sanitary facilities and waste storage, but it appeared that each homesite had its own porta potty and uncovered waste bin. Plan states that stockpiles will be in designated areas with BMPS as indicated on site plan, however site plan does not show any locations of BMPs other than a note that they will be added in the field. The North arrow was facing south on the site map and the street signs were incorrect.

NMED/SWQB Official Photograph Log		
Photo # 1		
Photographer: Jennifer Foote	Date: 2/13/19	Time: 2:04 pm
City/County: Las Cruces/Dona Ana		State: New Mexico
Location: Metro Park Village Phase 2		
Subject: SWPPP site map

- Permittee sent updated site map 2/26/19

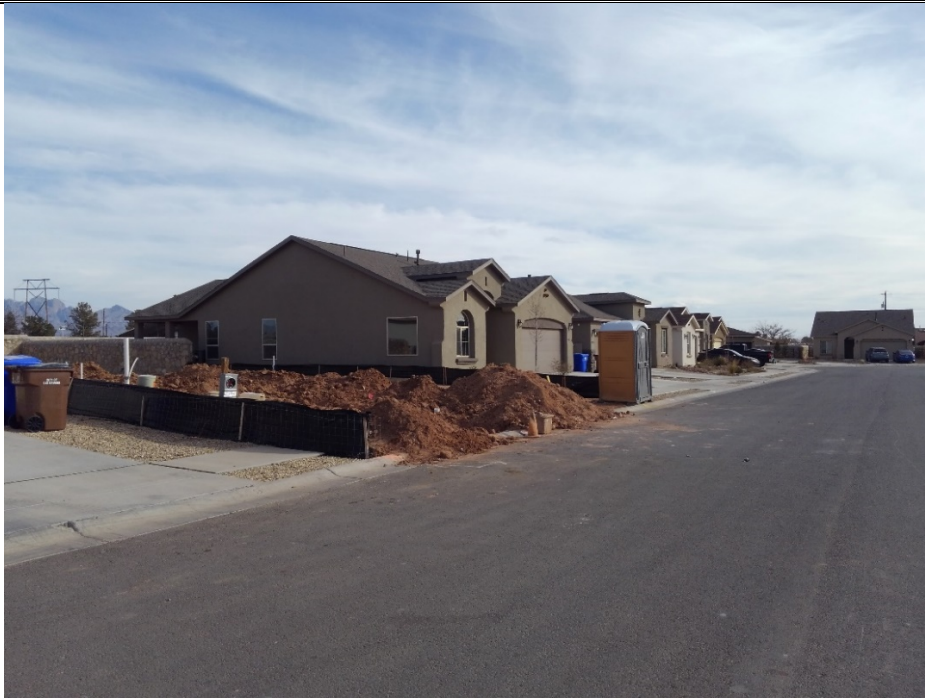
- Part 2.2.4.d Sediment track-out onto paved roads was not removed by the end of each day (photo 5)
- Part 2.2.5 Soil Stockpiles not located outside of the drainage pathway and upgradient of sediment barrier (Photo 2). Permittee sent photo of stockpiles removed on 2/26/19.
- Part 2.3.3 Waste containers were not covered when not in use and debris was blowing away (photo 3). Permittee sent photo of new waste bin covers on 2/26/19.
- Part 2.3.4 Stucco and paint washout was occurring at individual home sites and not always in the designated lined pit.(photo 3,4)

NMED/SWQB Official Photograph Log Photo # 2		
Photographer: Jennifer Foote	Date: 2/13/19	Time: 3:25 pm
City/County: Las Cruces/Dona Ana		State: New Mexico
Location: Metro Park Village Phase 2		
Subject: Spoils piles in gutter

- Permittee sent photo of stockpiles removed on 2/26/19.

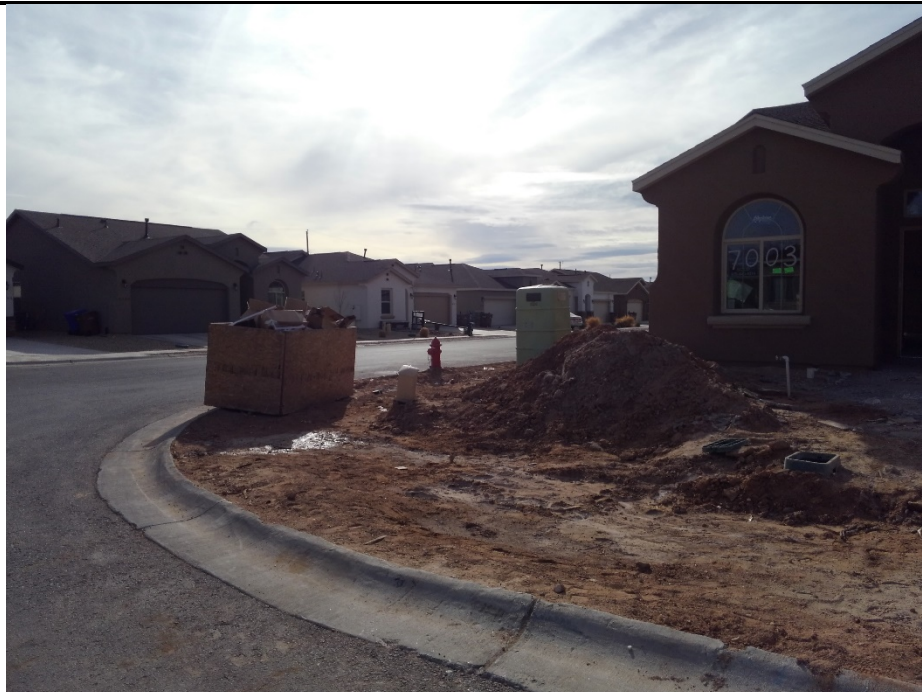
NMED/SWQB Official Photograph Log Photo # 3		
Photographer: Jennifer Foote	Date: 2/13/19	Time: 3:22 pm
City/County: Las Cruces/Dona Ana		State: New Mexico
Location: Metro Park Village Phase 2		
Subject: Overflowing uncovered waste bin, washout on ground, site not below curb grade

Part 2.3.3 Waste containers were not covered when not in use and debris was blowing away (photo 3).

- Permittee sent photo of new waste bin covers on 2/26/19.

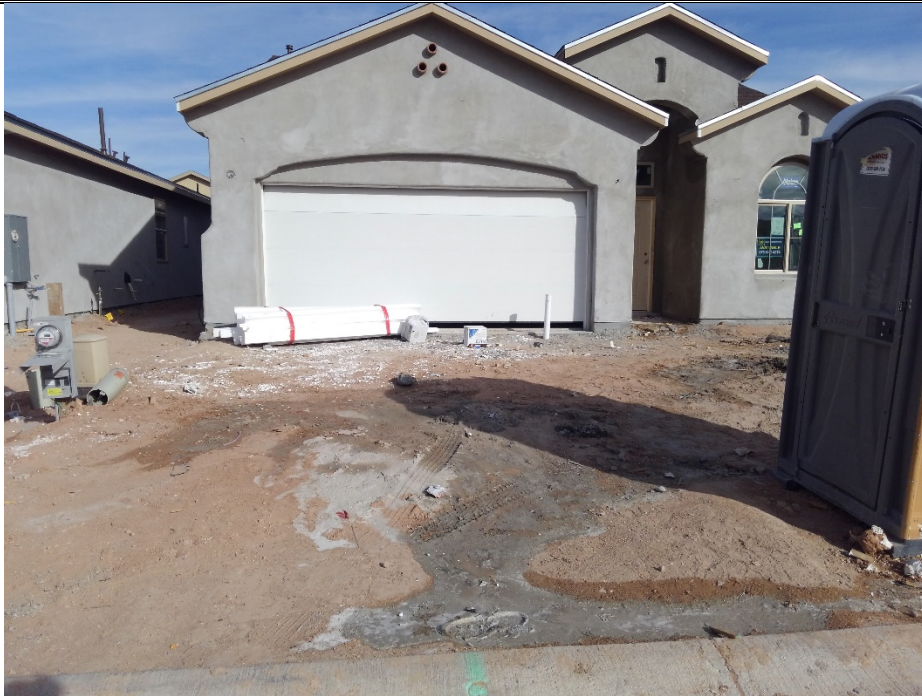
NMED/SWQB Official Photograph Log Photo # 4		
Photographer: Jennifer Foote	Date: 2/13/19	Time: 3:25 pm
City/County: Las Cruces/Dona Ana		State: New Mexico
Location: Metro Park Village Phase 2		
Subject: stucco washout occurring outside of washout area

• Part 2.3.4 Stucco and paint washout was occurring at individual home sites and not always in the designated lined pit.(photo 3,4)

- Hakes Brothers implementing Paint and Stucco washout areas using hard line containers. (Rigid youth swimming pool)

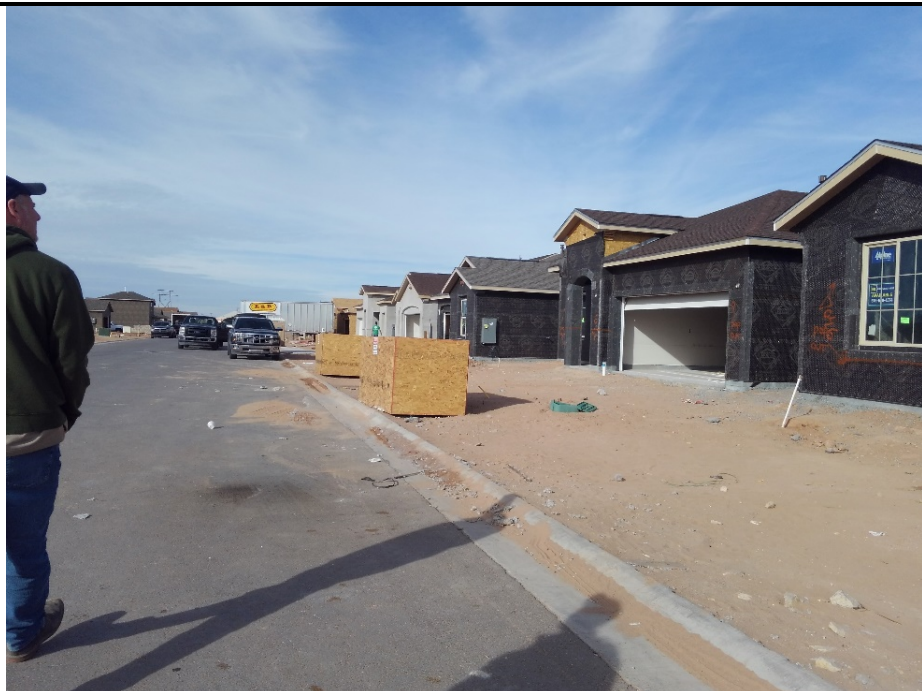
NMED/SWQB Official Photograph Log Photo # 5		
Photographer: Jennifer Foote	Date: 2/13/19	Time: 2:04 pm
City/County: Las Cruces/Dona Ana		State: New Mexico
Location: Metro Park Village Phase 2		
Subject: sediment in gutter and road

Part 2.2.4.d Sediment track-out onto paved roads was not removed by the end of each day (photo 5)

- Hakes Brothers conducts street sweeps on a Bi-monthly basis. Additionally, street sweeps are scheduled during heavy dirt work times.

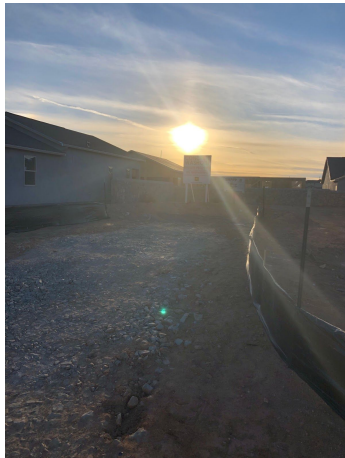
Part 1.5 SWPPP Public posting was inaccessible to the public.

- Permittee sent photo of relocated sign on 2/26/19.

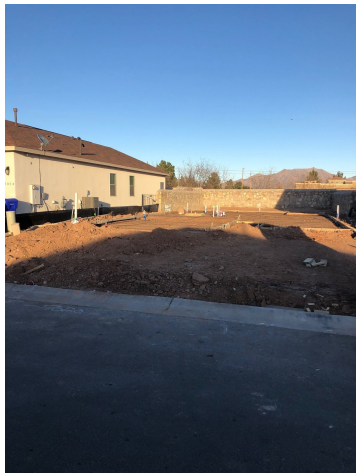
Part 2.2.5 Soil Stockpiles not located outside of the drainage pathway and upgradient of sediment barrier.
